Case Study: Eliminating corrosion of antennas on locomotive rooftops benefits operating and capital budgets

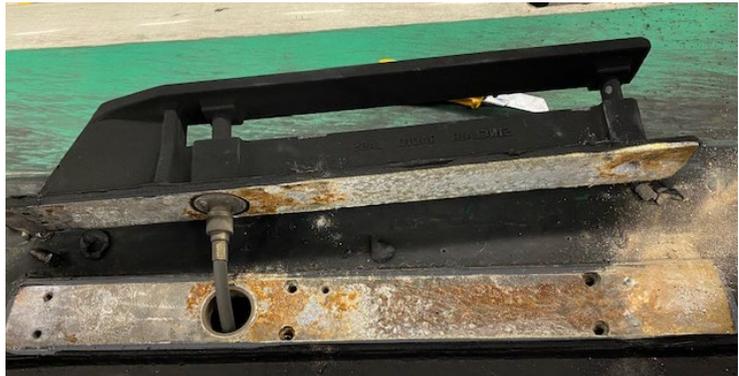
A North American Transit system recognized corrosion problems with antennas on the rooftops of their locomotives used for commuter rail service. The aluminum bases of the antennas suffered significant corrosion that was affecting communication performance and requiring considerable maintenance manhours. It was determined that the bond sealant used around the antenna base and at each bolt head was not preventing **moisture infiltration**. In addition, corrosion was accelerated where the aluminum antennas were mounted directly against a steel body due to the **galvanic effect of dissimilar metal contact**.

The harsh environment of rail operations accelerates corrosion. Unrelenting **vibration and thermal variations** cause standard sealants to crack, de-bond and fail more quickly, thereby permitting moisture to intrude.

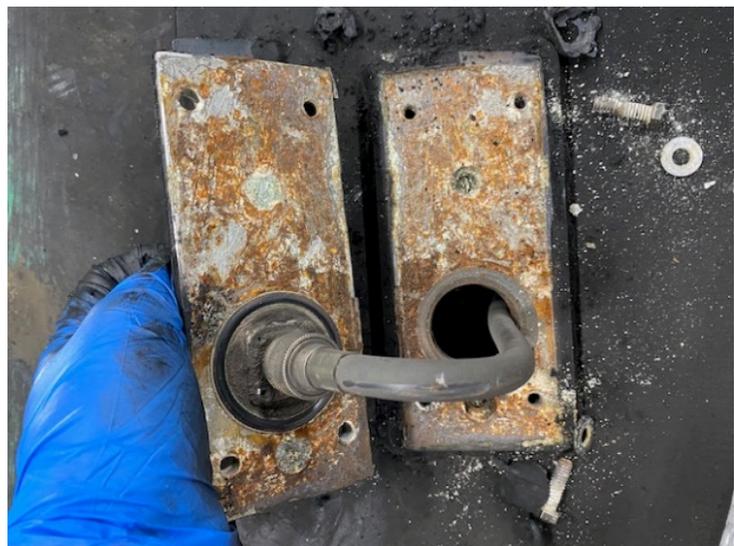
In this situation, corrosion caused disruption in the antenna performance, increased manpower use/costs, and required considerable unnecessary downtime for their locomotives – making these expensive company assets non-productive.

- RF transmission impairment and signal distortion
- Loss of electrical ground/bond
- EMI performance affected by corrosion
- Antenna replacement cost – product lifespan was reduced to months, rather than multiple years
- Substantial added labor cost attributable to frequent inspections and extensive maintenance time needed to repair/replace antennas
- Increased locomotive downtime

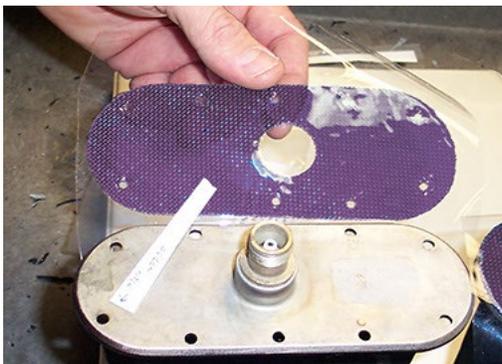
These **Corr-Cut gaskets** are die cut from conductive mesh encapsulated with a soft, tacky and pliable polyurethane sealant that compresses to fill gaps between the surfaces under the antenna. The conductive aluminum mesh carrier provides the electrical bonding needed, and the polyurethane gel protects the metal surfaces from galvanic corrosion. (CorrSolve also offers Corr-Cut gaskets made from non-conductive mesh, and without mesh.)

Above: Example of a Corr-Cut gasket showing the conductive mesh. Corr-Cut gaskets are die-cut for each antenna model to ensure a precise fit and easy installation.

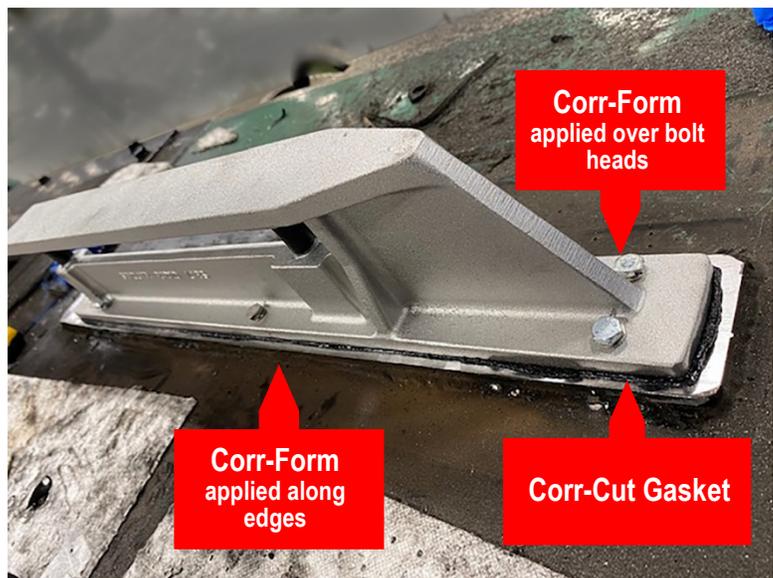
Right: One of the antenna models described in this case study is shown installed with all recommended CorrSolve solutions.

Corr-Form is a UV-resistant waterproofing sealant for perimeter gaps and structure edges. Corr-Form applies easily with the CorrSolve dispenser tool and cures in just one hour. As a remedy for this situation, Corr-Form was applied to cover the bolt heads and along all exposed edges to prevent moisture intrusion.
